Naval Research Laboratory

NRL/MR/6180-92-7145

## Findings of Portable Air Mover Tests on the ex-USS SHADWELL

September 30, 1992

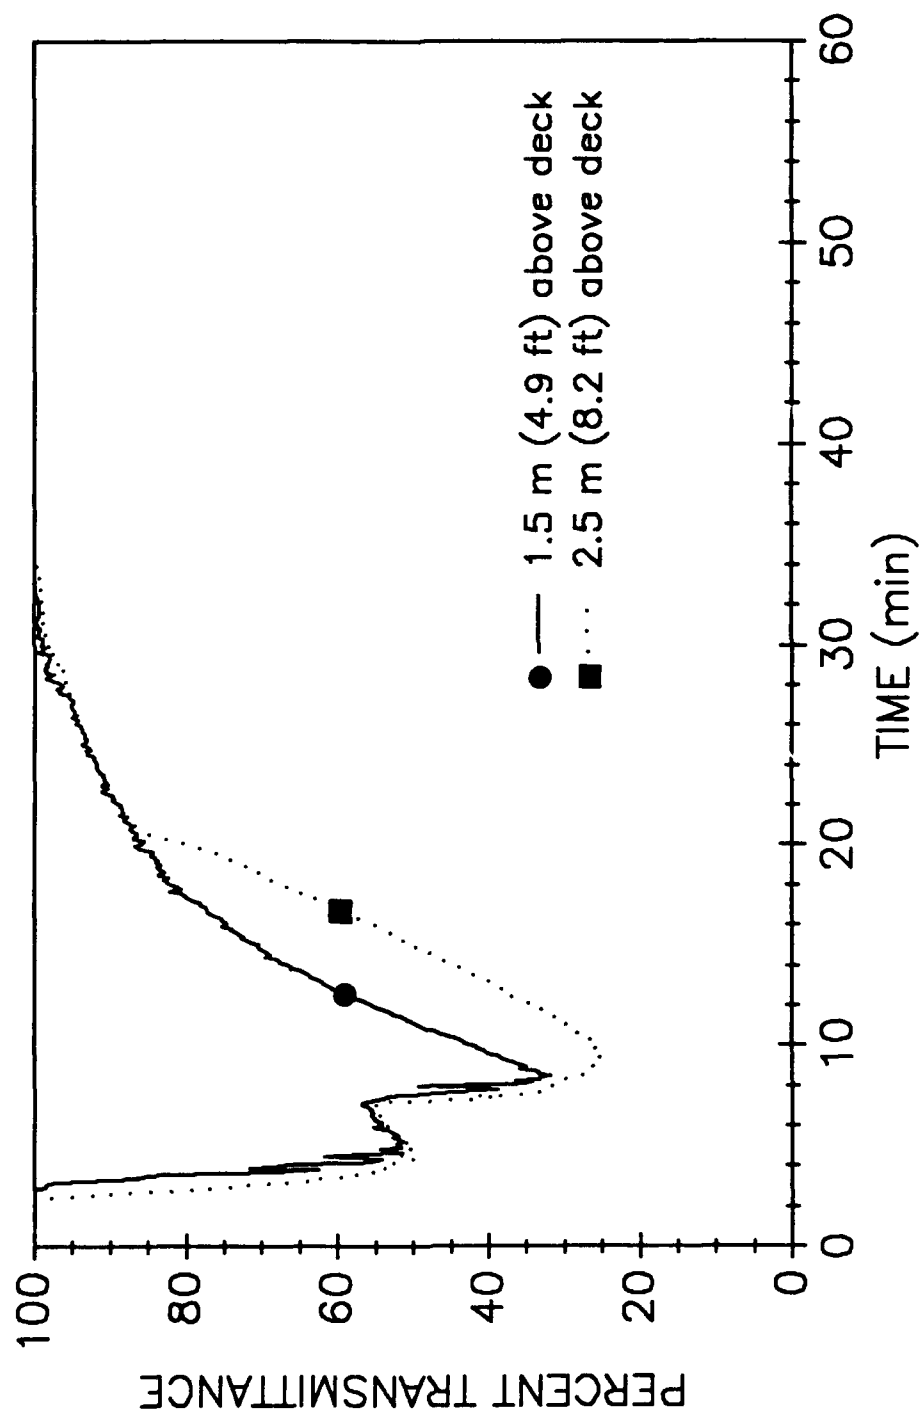
Fig. 32 - Percent transmittance in RICER 1 during FAN\_22  
using RAMFAN 1000 kPa (145 psi)

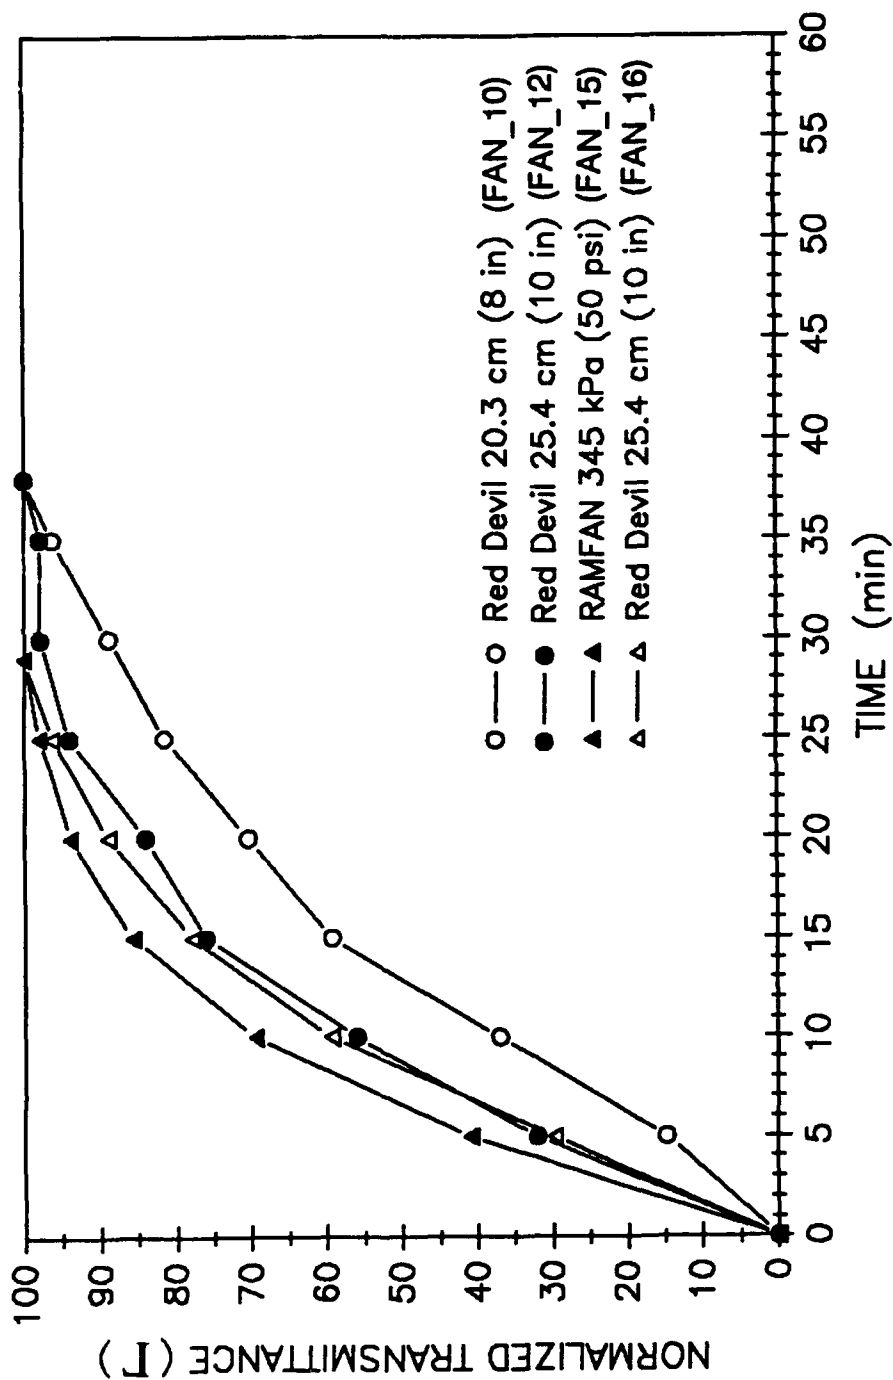
Fig. 33 - Recovery of normalized transmittance at 3rd deck -  
2.5 m level after fan is activated

Figures 33 through 38 show the normalized transmittance for the selected unmanned and manned tests. The smoke meter located 2.5 m (8 ft) above the deck in BERTHING 1 and RICER 1 and at the lintel between BERTHING 1 and 2 were selected as the best representation of the flow of smoke for these tests. The initial negative values in Fig. 35 for the second deck is attributed to the desmoking fan drawing smoke from the third deck, i.e. the initial concentration of smoke in RICER 1 was less than when the fan was activated. The negative values were also observed in the manned tests at the second deck (Fig. 38). From Figs. 33 through 35, it is shown that the Red Devil with the 25.4 cm (10 in.) duct improved the transmittance more quickly than the Red Devil 20.3 cm (8 in.) duct. For example, in Fig. 33 at 10 minutes, the transmittance, using the Red Devil 25.4 cm (10 in.), is 58% recovered compared to the transmittance of the Red Devil 20.3 cm (8 in.) which is only 38% recovered. When comparing the Red Devil 25.4 cm (10 in.) to the RAMFAN at low pressures (345 kPa (50 psi)), the two fans were essentially comparable as seen in Fig. 33 and 37. However, the RAMFAN at high pressures (965 kPa (145 psi)) improved the transmittance faster than the other fans tested (Figs. 36 and 37).

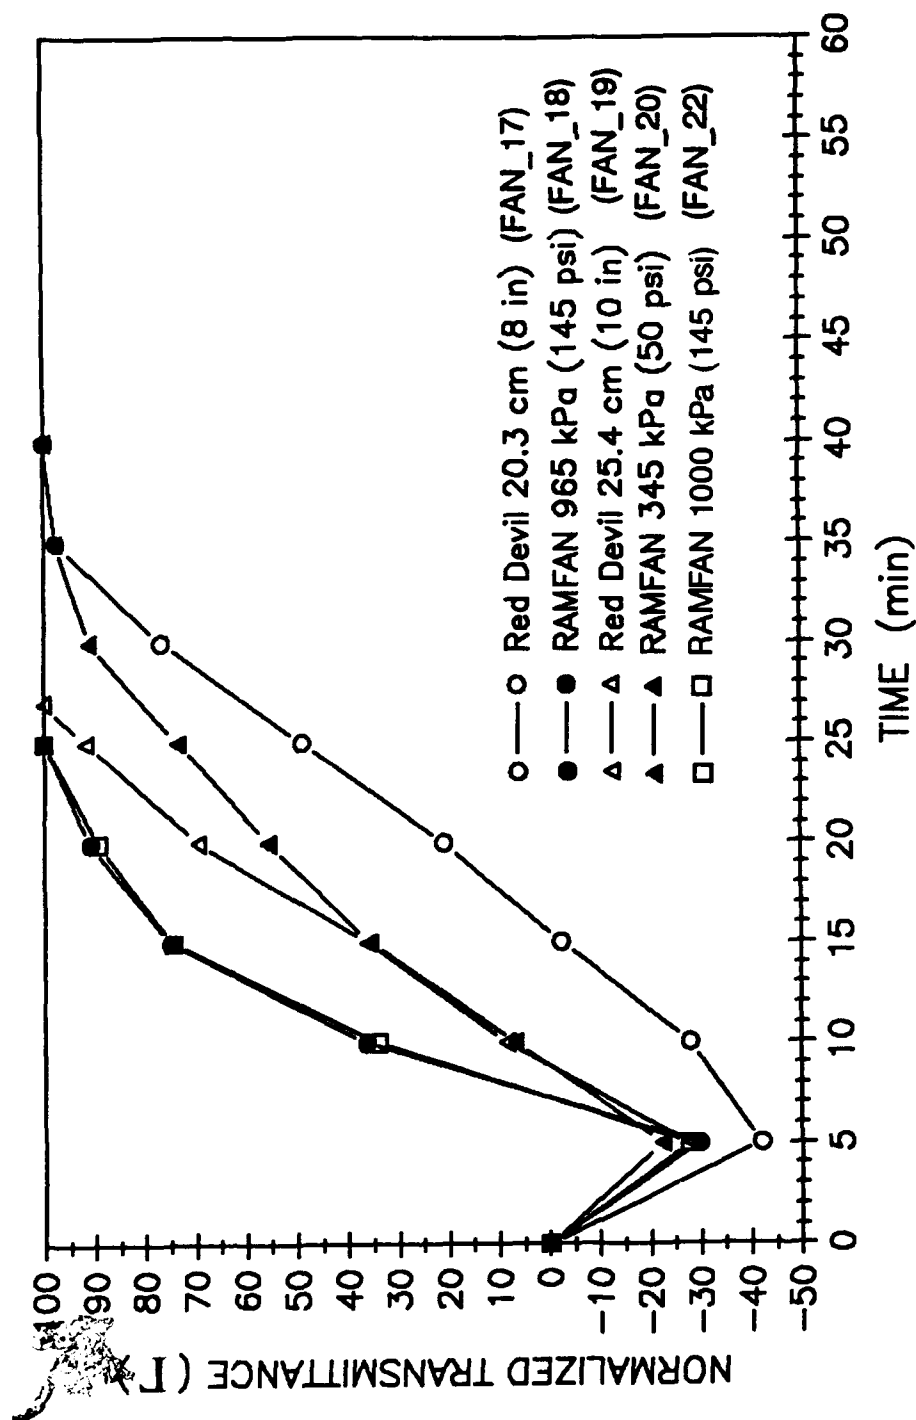
Fig. 38 - Recovery of normalized transmittance at 2nd deck - 2.5 m level after fan is activated

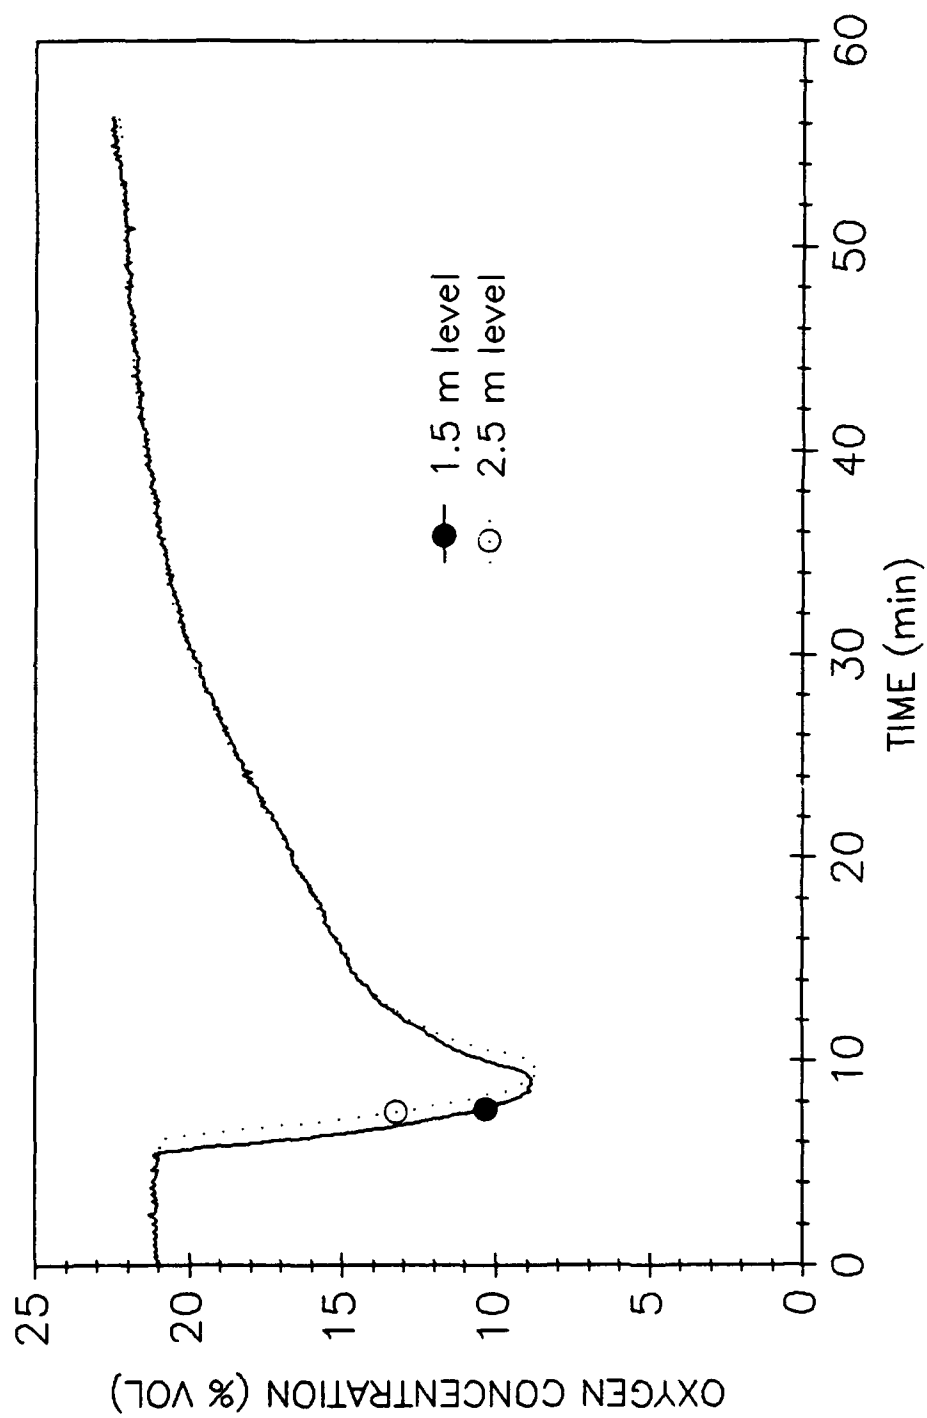
Fig. 39 - Oxygen concentrations in BERTHING 1. during FAN\_10  
using Red Devil 20.3 cm (8 in) duct

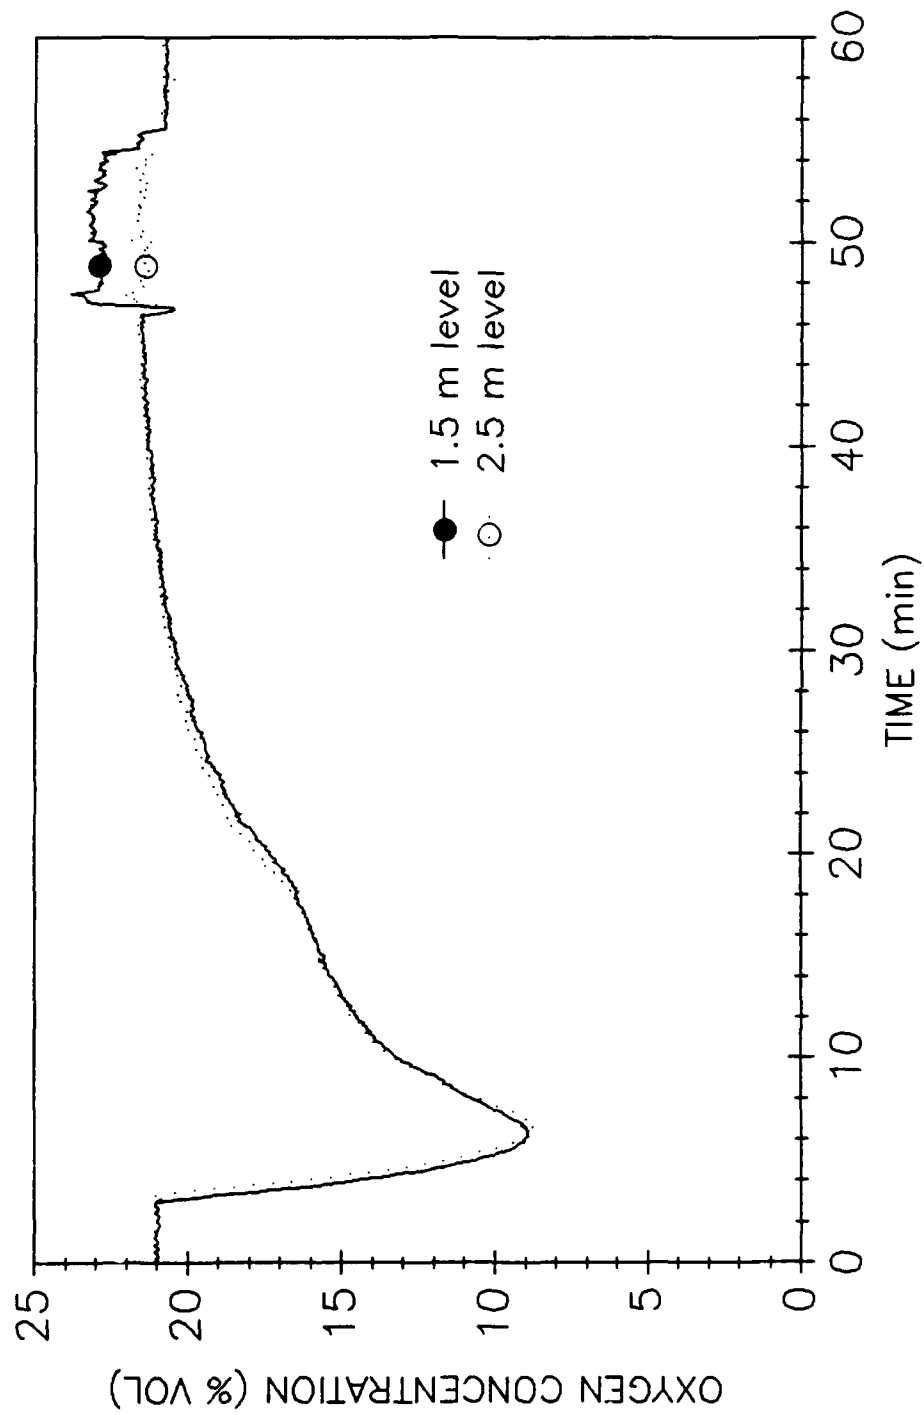
Fig. 40 - Oxygen concentrations in BERTHING 1 during FAN\_12  
using Red Devil 25.4 cm (10 in) duct

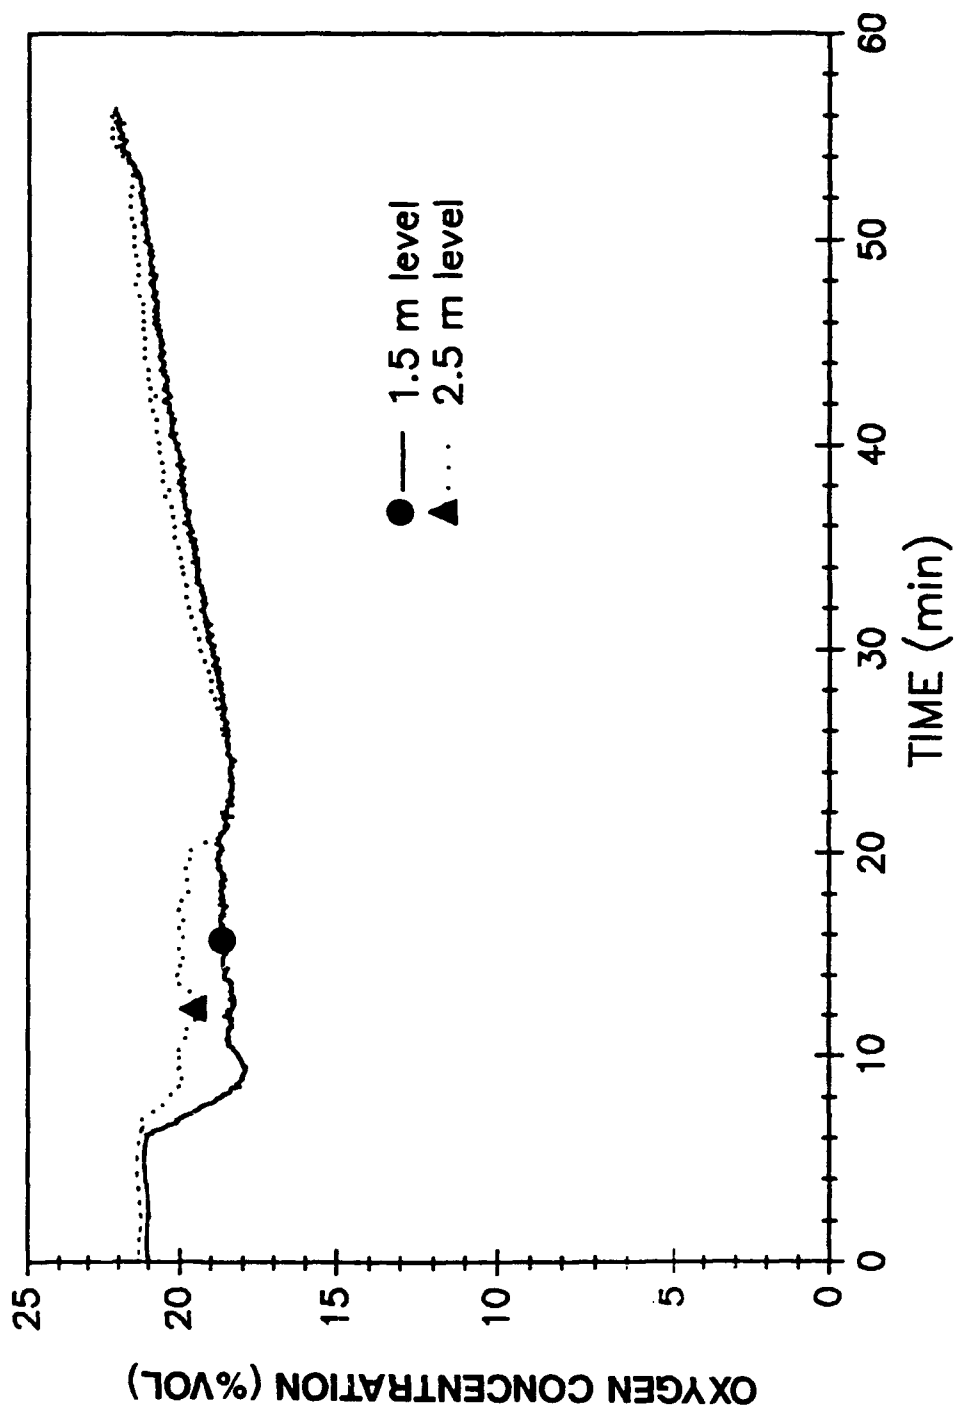
Fig. 48 - Oxygen concentrations in RICER 1 during FAN\_10  
using Red Devil 20.3 cm (8 in)

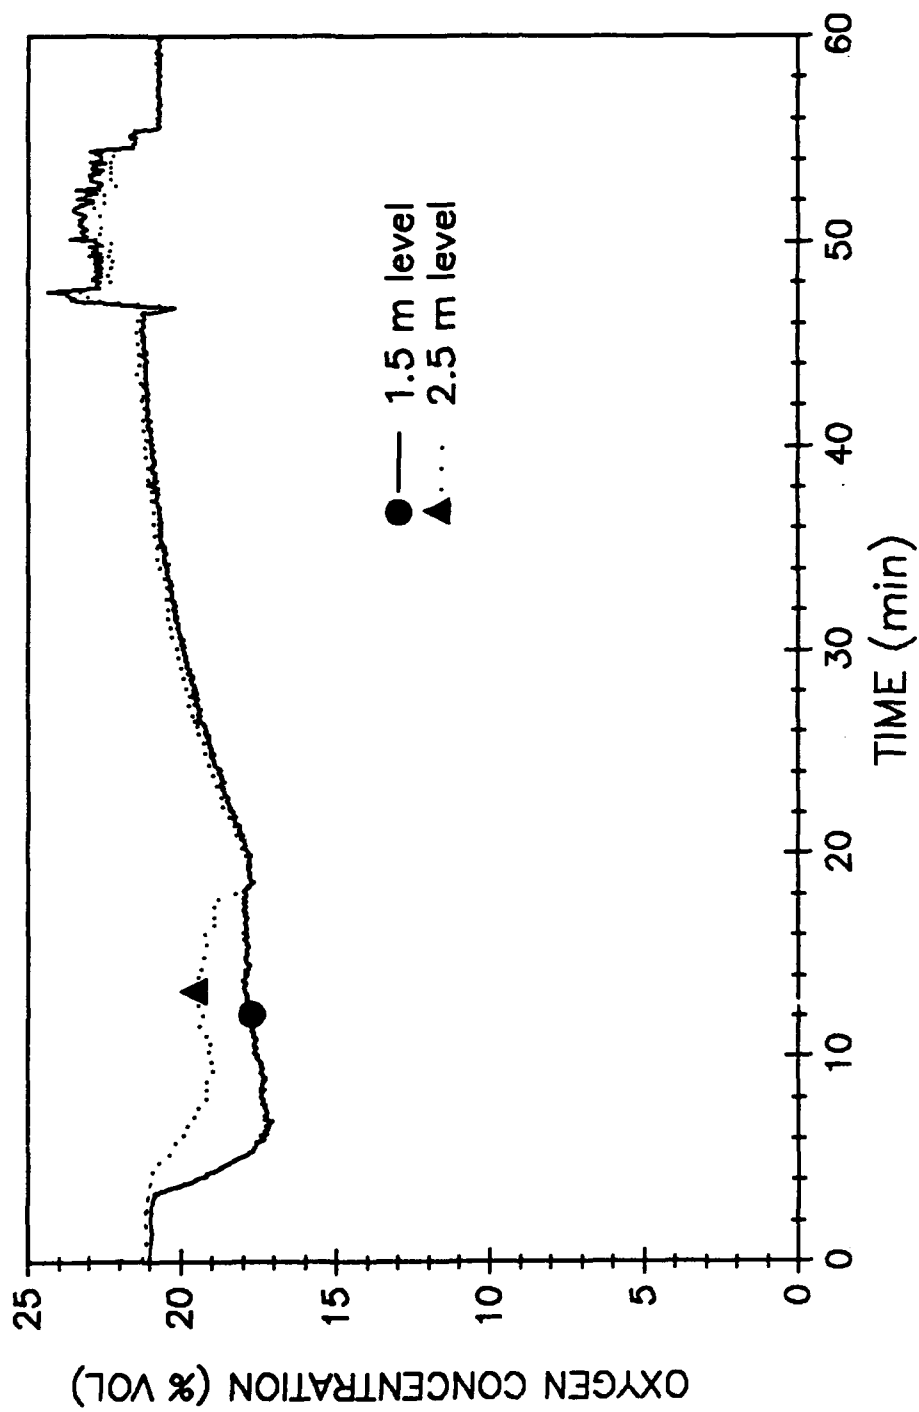
Fig. 49 - Oxygen concentrations in RICER 1 during FAN\_12  
using Red Devil 25.4 cm (10 in)

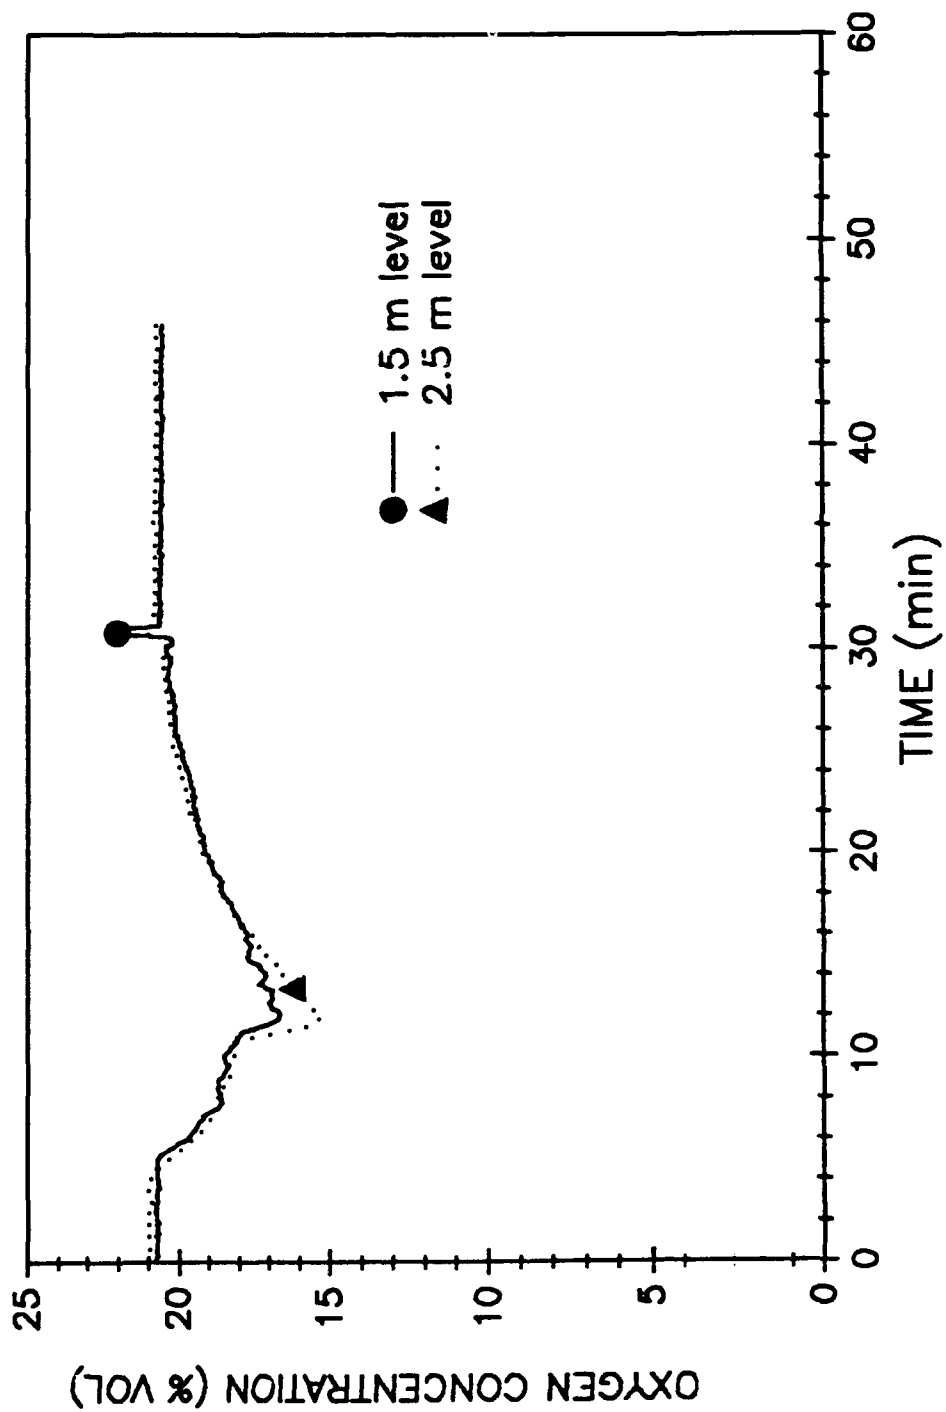
Fig. 53 - Oxygen concentrations in RICER 1 during FAN\_18  
using RAMFAN 965 kPa (145 psi)

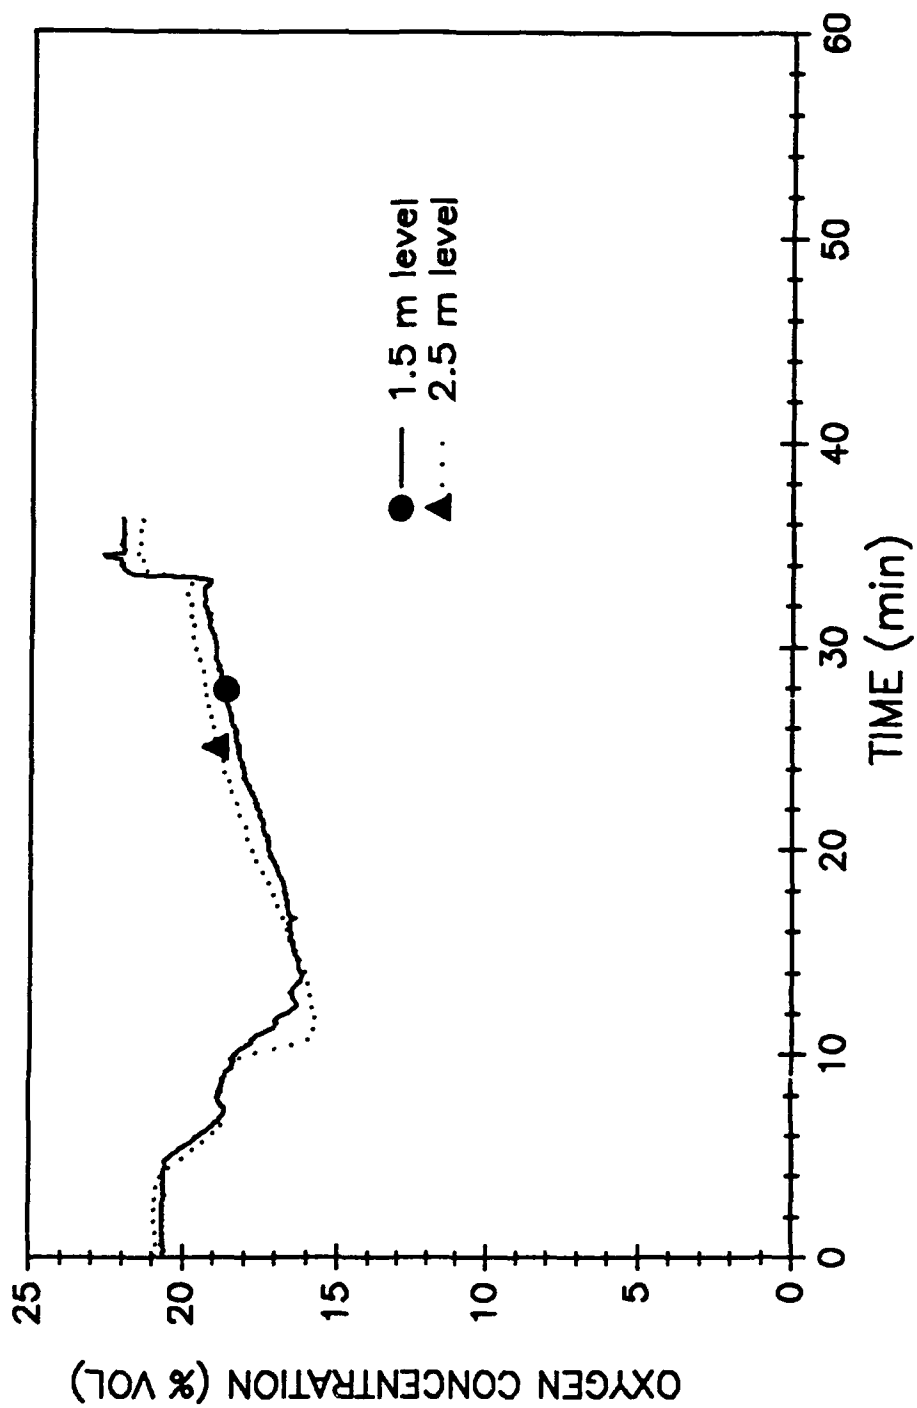
Fig. 54 - Oxygen concentrations in RICER 1 during FAN\_19  
using Red Devil 25.4 cm (10 in)

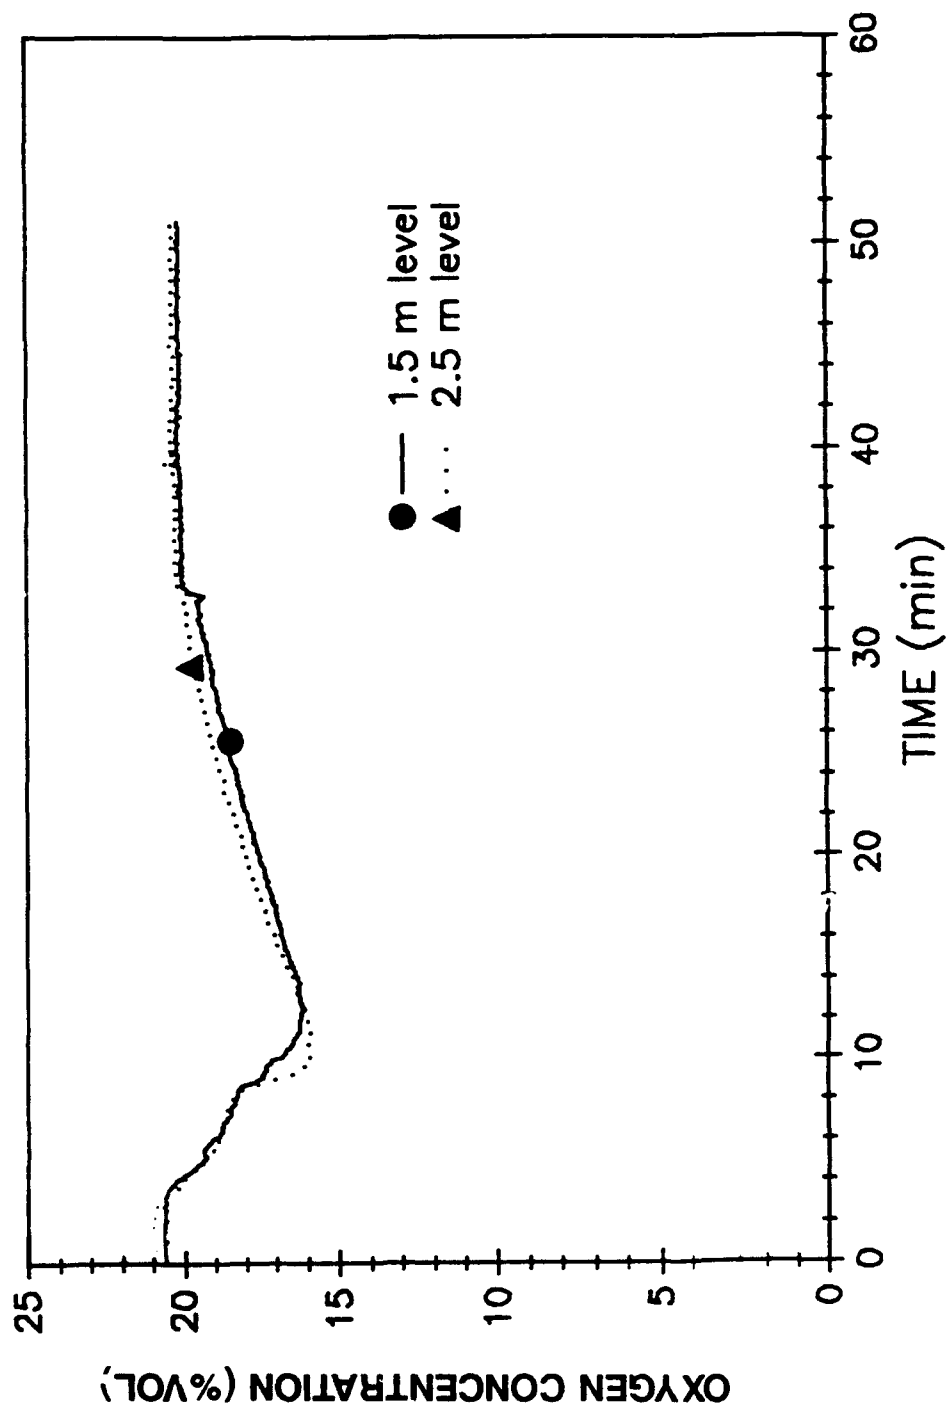
Fig. 55 - Oxygen concentrations in RICER 1 during FAN\_20  
using RAMFAN 345 kPa (50 psi)

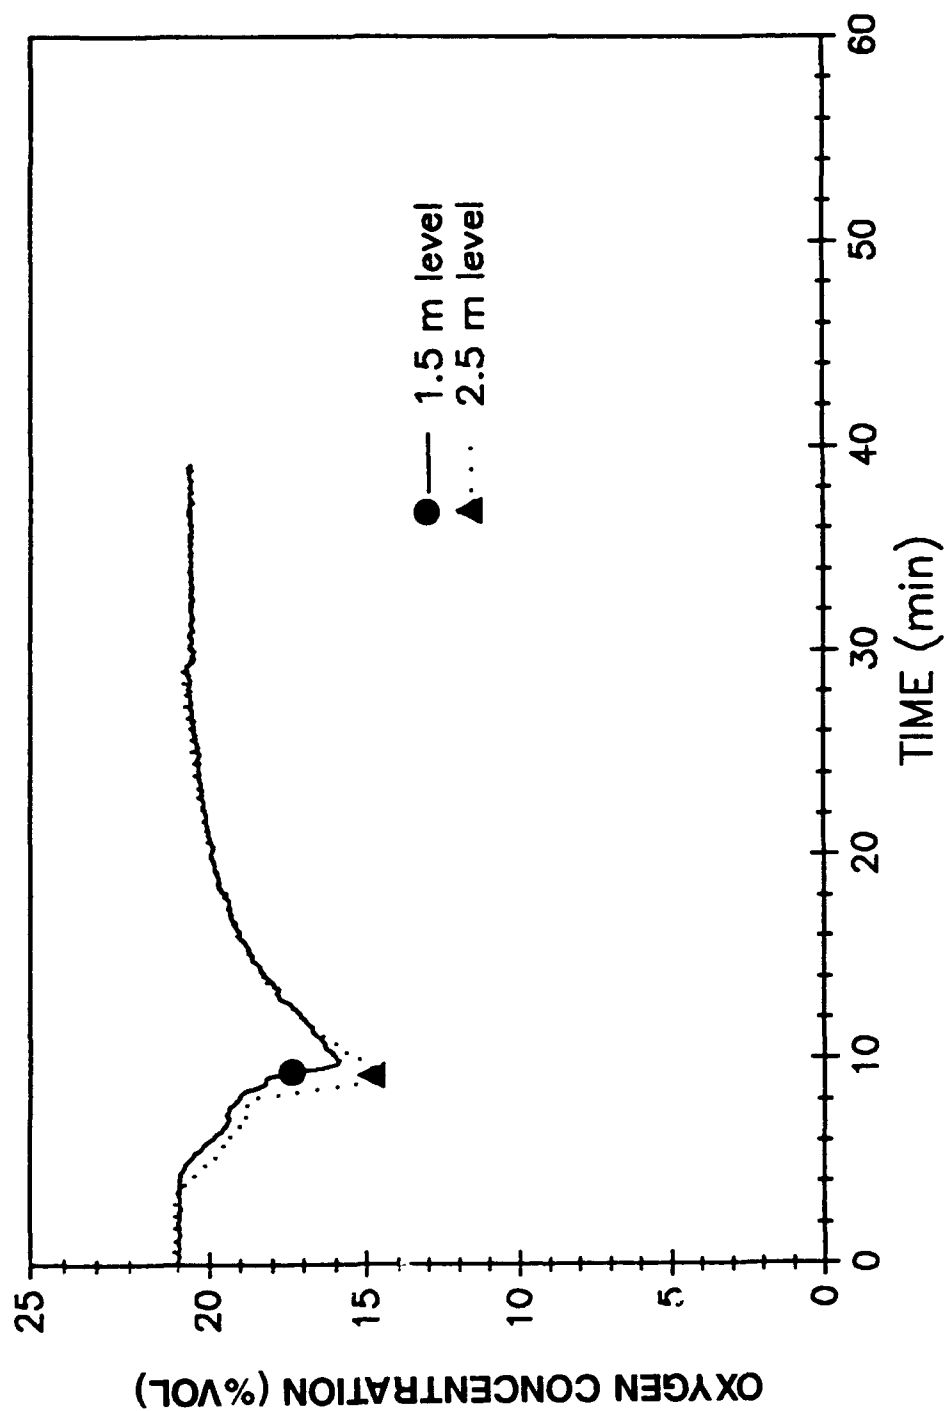
Fig. 56 - Oxygen concentrations in RICER 1 during FAN\_22  
using RAMFAN 965 kPa (145 psi)

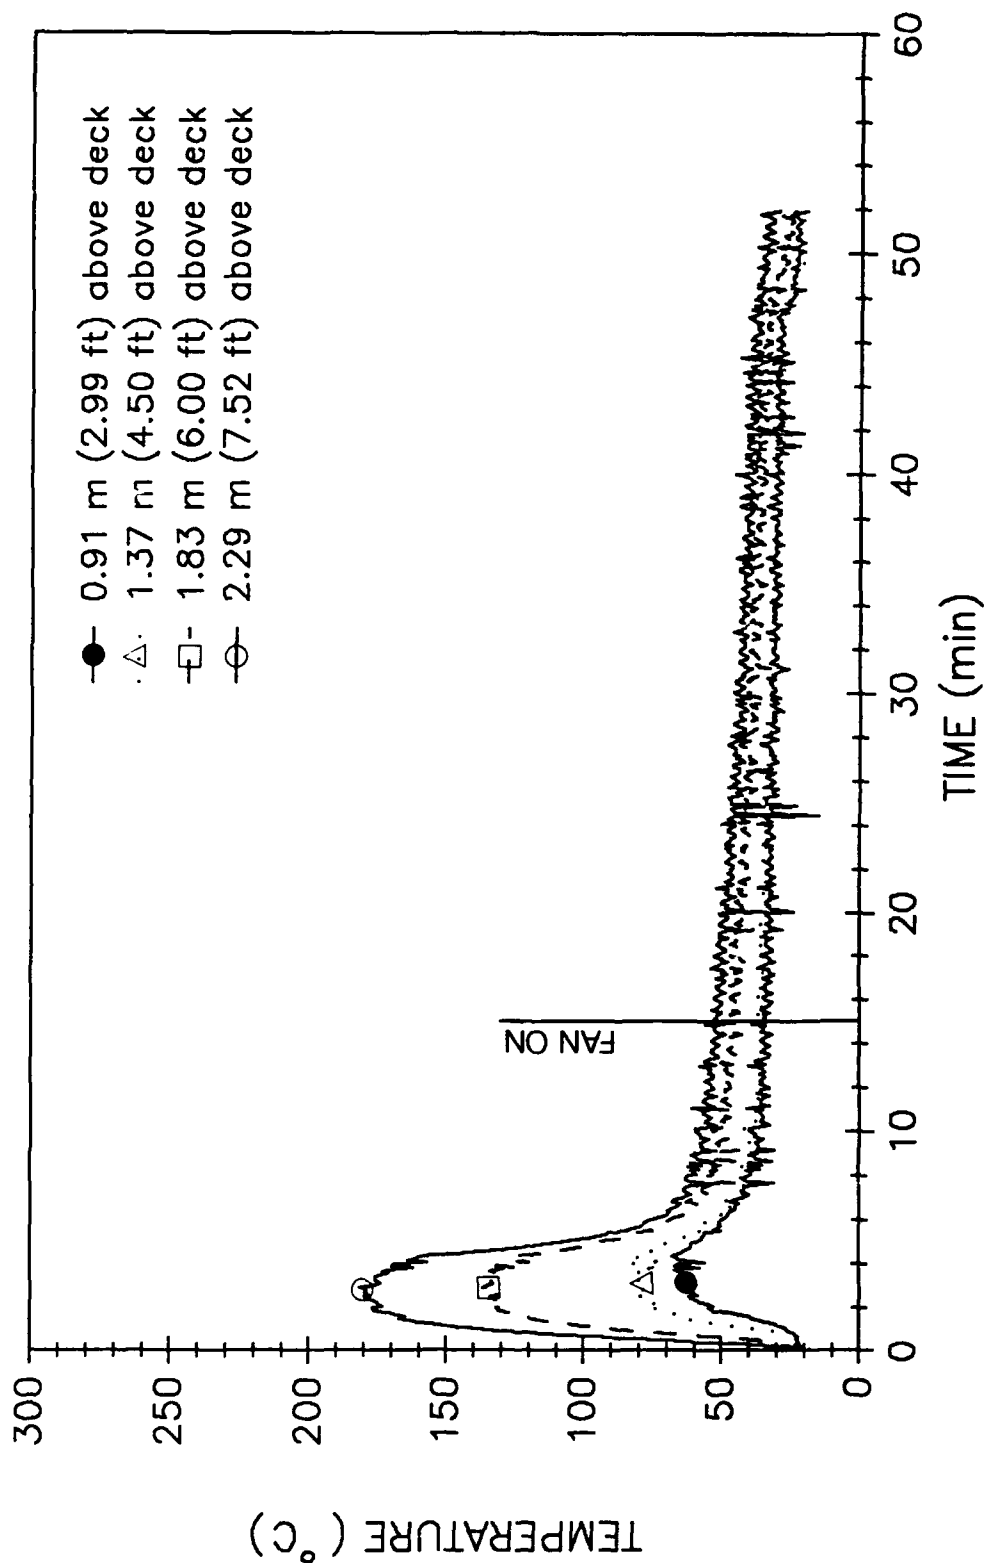
Fig. 61 - Temperature in BERTHING 1 (3-79-2) during FAN\_10 using Red Devil 20.3 cm (8 in) duct

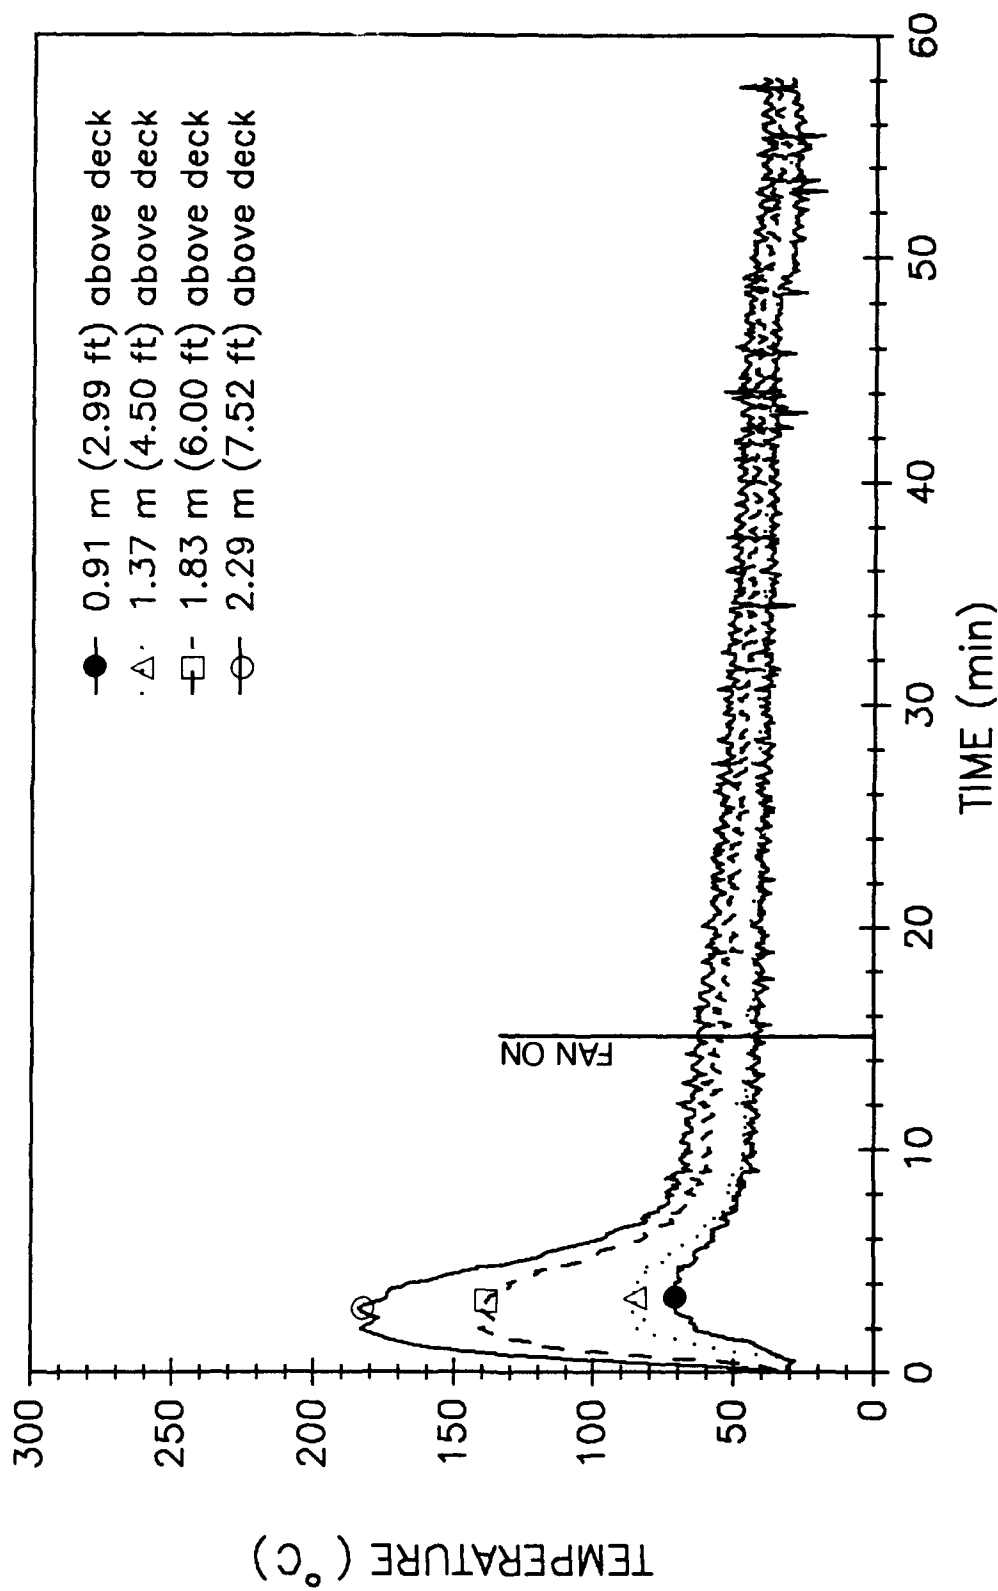
Fig. 62 - Temperature in BERTHING 1 (3-79-2) during FAN\_12  
using Red Devil 25.4 cm (10 in) duct

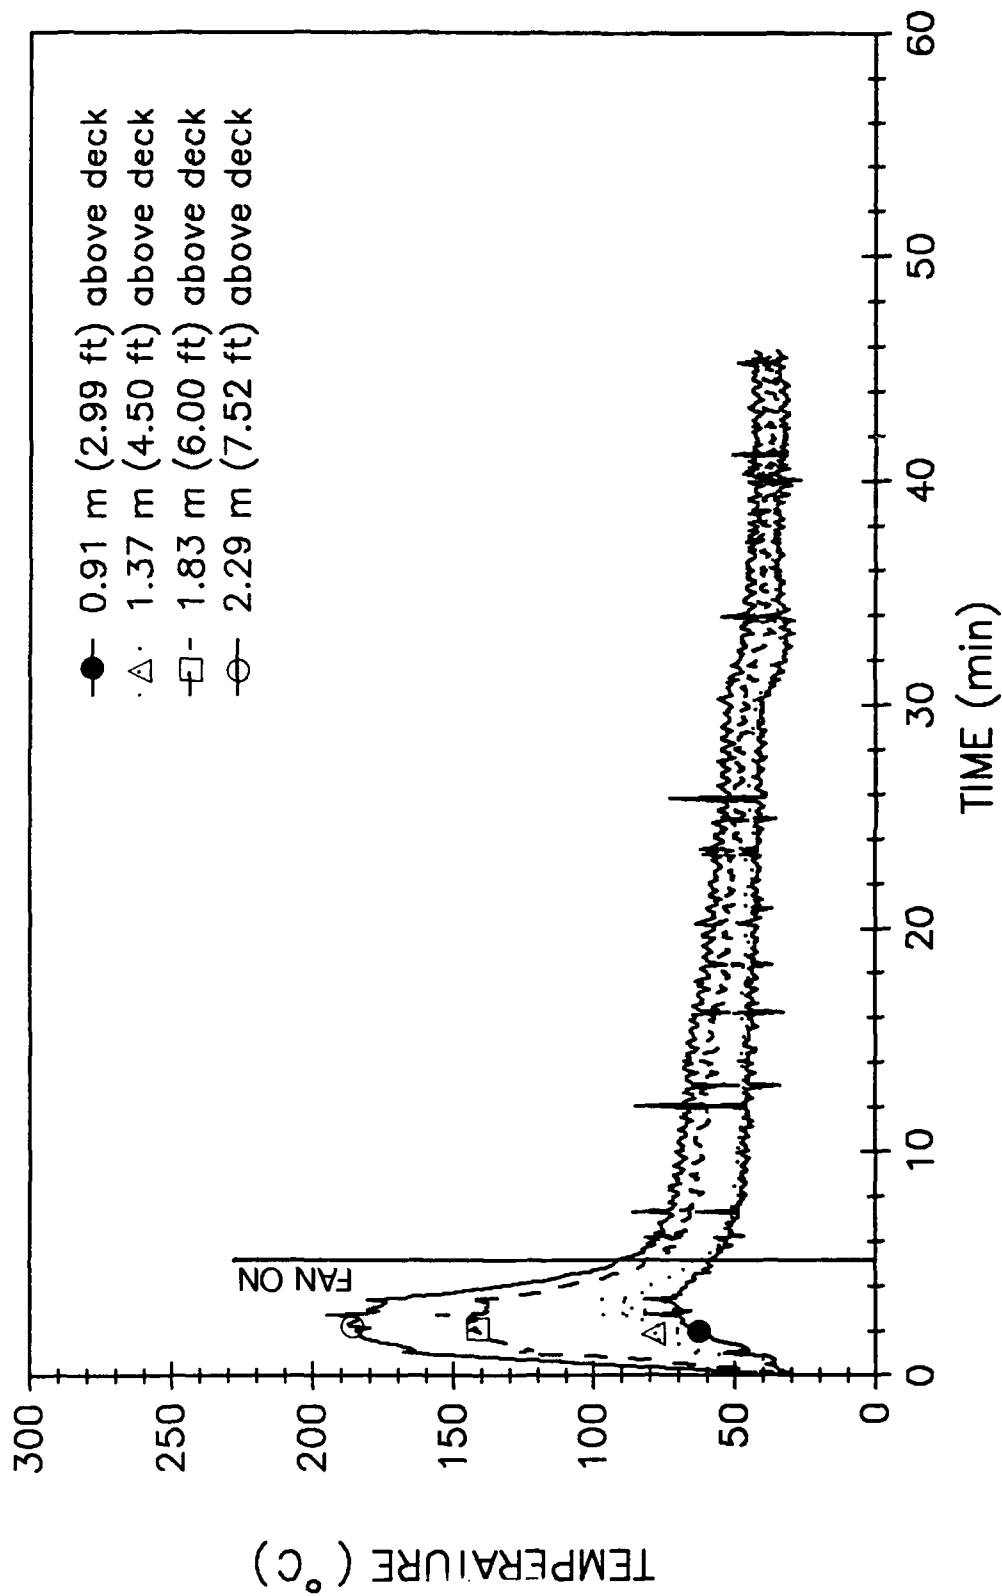
Fig. 63 - Temperature in BERTHING 1 (3-79-2) during FAN\_15 using RAMFAN 345 kPa (50 psi)

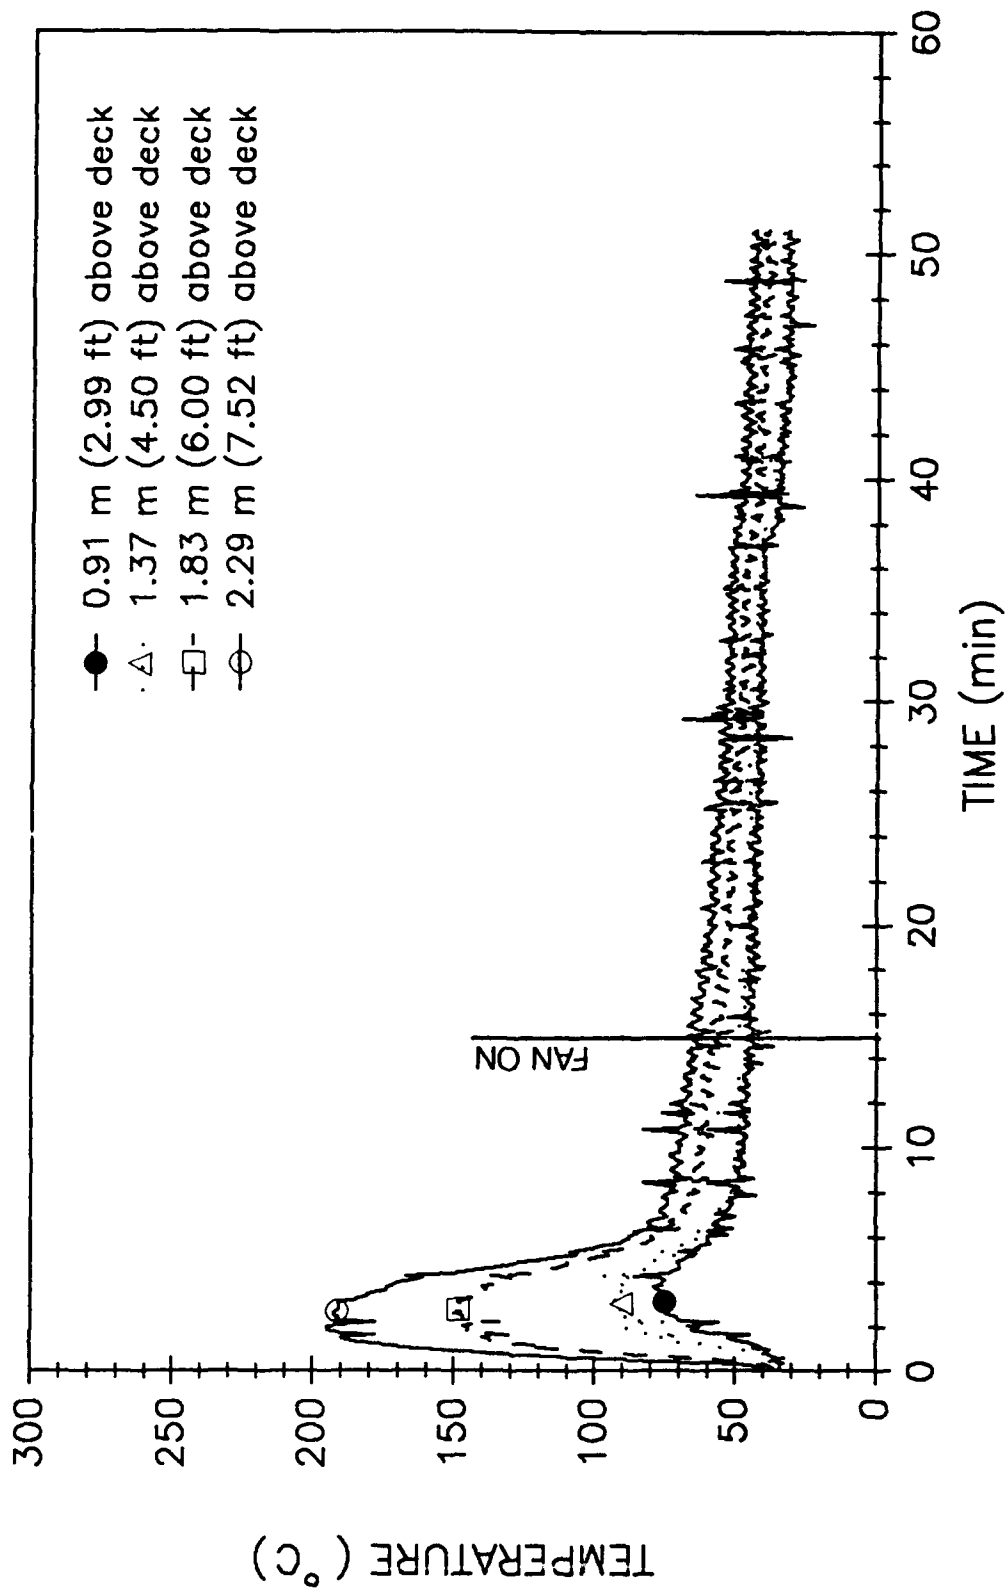
Fig. 64 - Temperature in BERTHING 1 (3-79-2) during FAN\_16  
using Red Devil 25.4 cm (10 in) duct

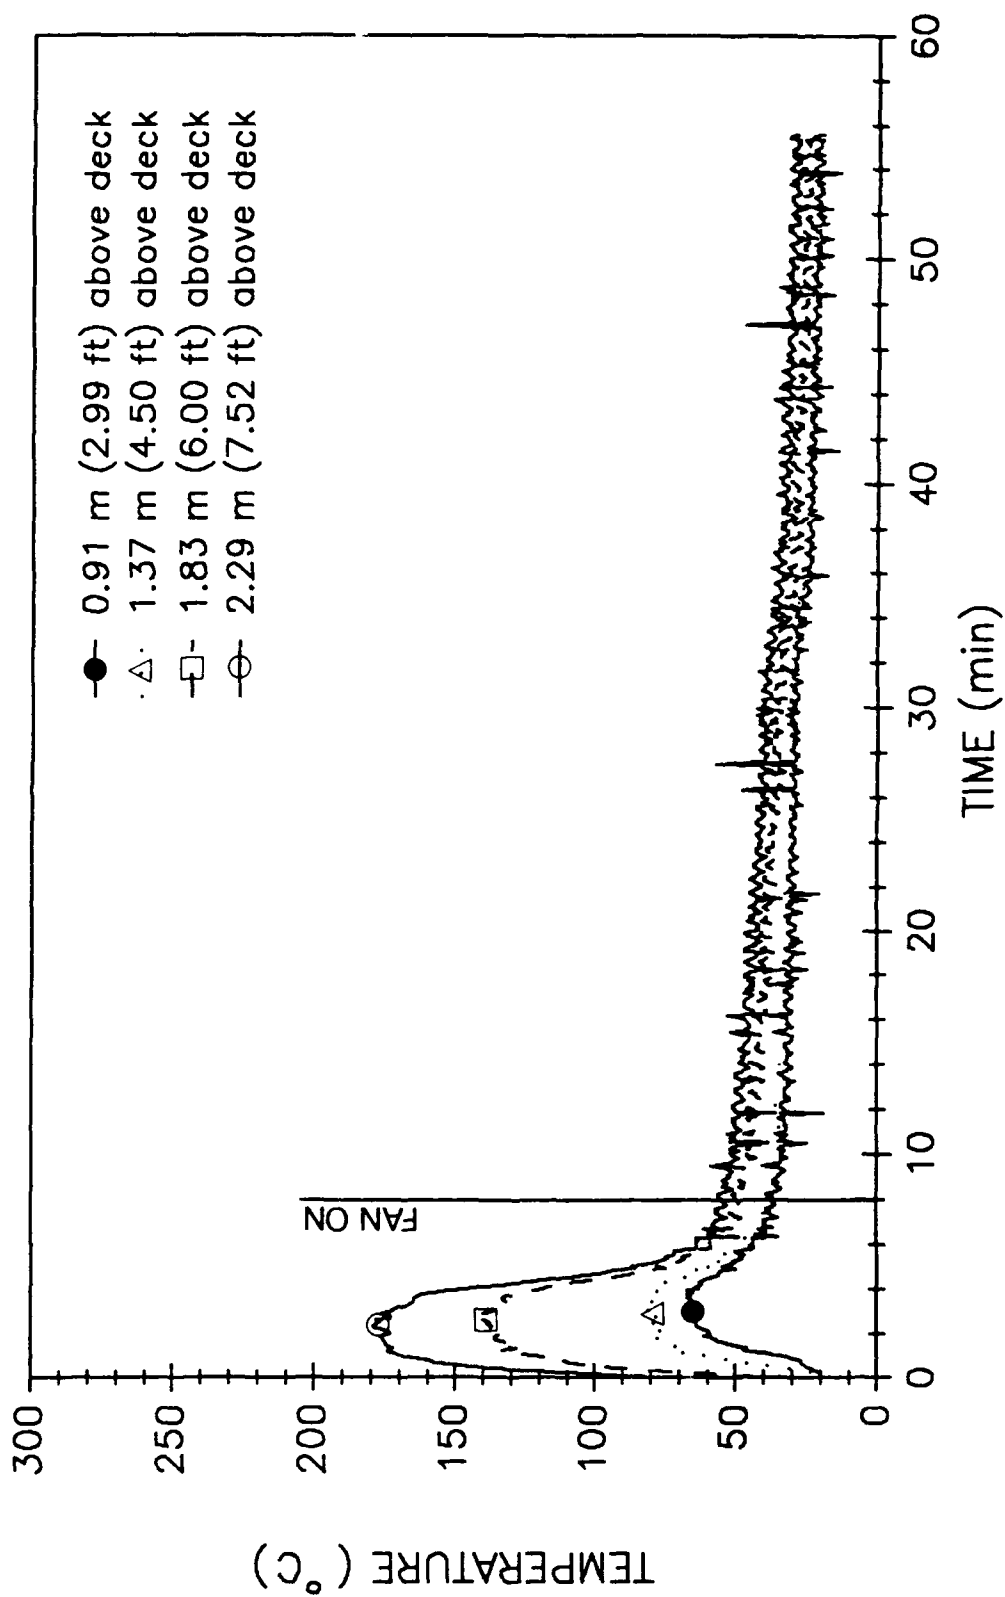
Fig. 65 - Temperature in BERTHING 1 (3-79-2) during FAN\_17 using Red Devil 20.3 cm (8 in) duct
